# State of Utah

### Division of Oil, Gas & Mining

### Inspection Report Minerals Regulatory Program

<b>Mine Name:</b> Jumbo-Jensen Quarry	<b>Permit Number:</b> M/041/0008
<b>Operator Name:</b> United States Gypsum Company	<b>Inspection Date:</b> March 31, 2011
<b>Inspector(s):</b> Peter Brinton, Paul Baker	<b>Time:</b> 10:00am to 3:00pm
<b>Other Participants:</b> Jeremy Taylor & Bruce Allen, US Gypsum	<b>Mine Status:</b> Active

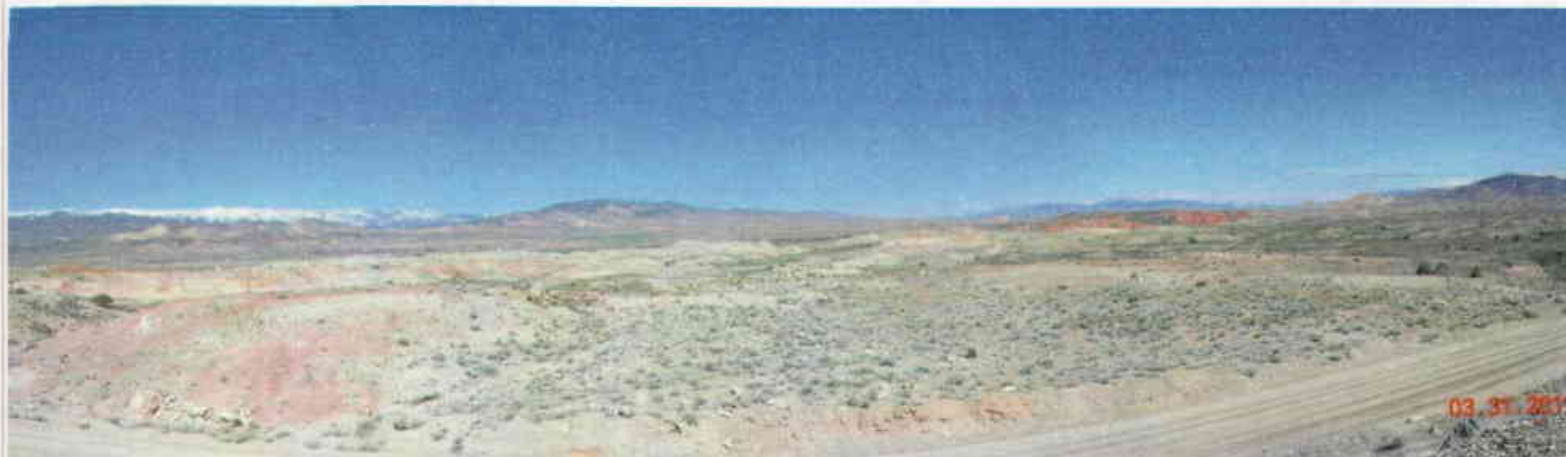
Revegetated areas of F1 are located in the center and left of the photo. Note the natural areas of both sparse and less sparse vegetation to the rear. Stitched photo.

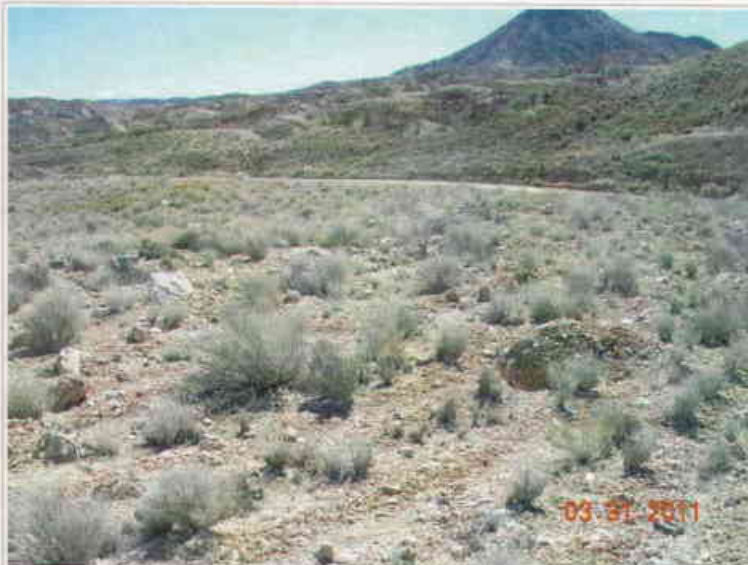
Revegetated area on F1.

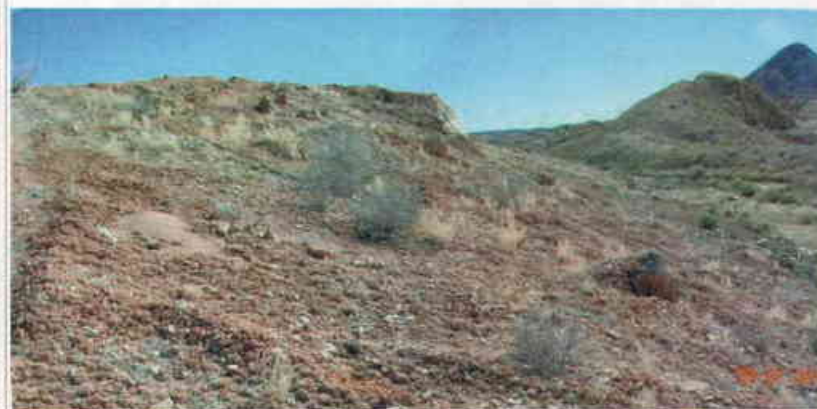
Revegetated hillside on F1.

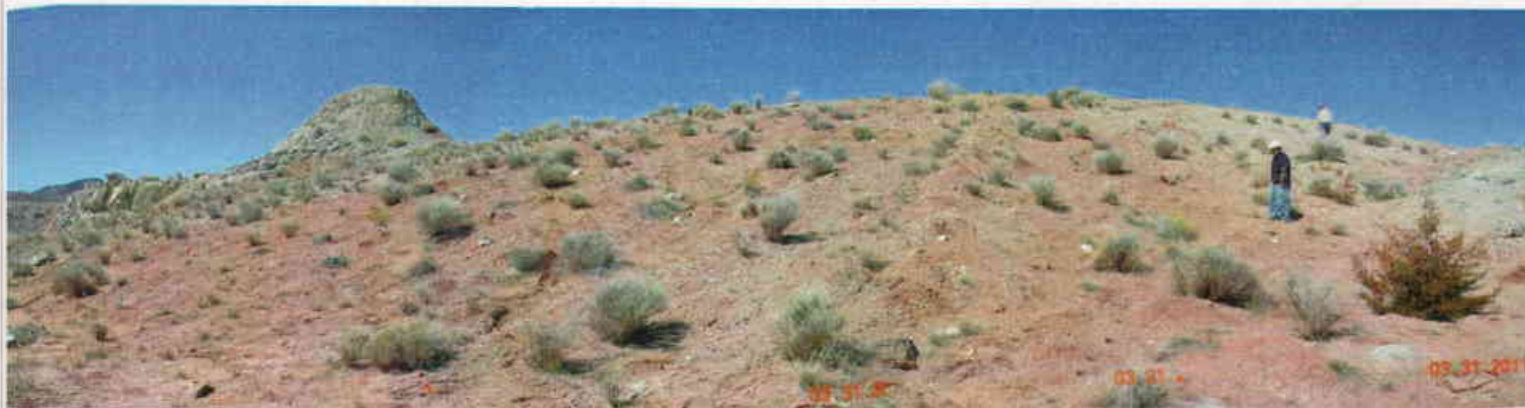
Revegetated hillside on Center 4A (stitched photo). The shrubs grew from seed. The juniper on the left and others at this site were apparently potted plants.

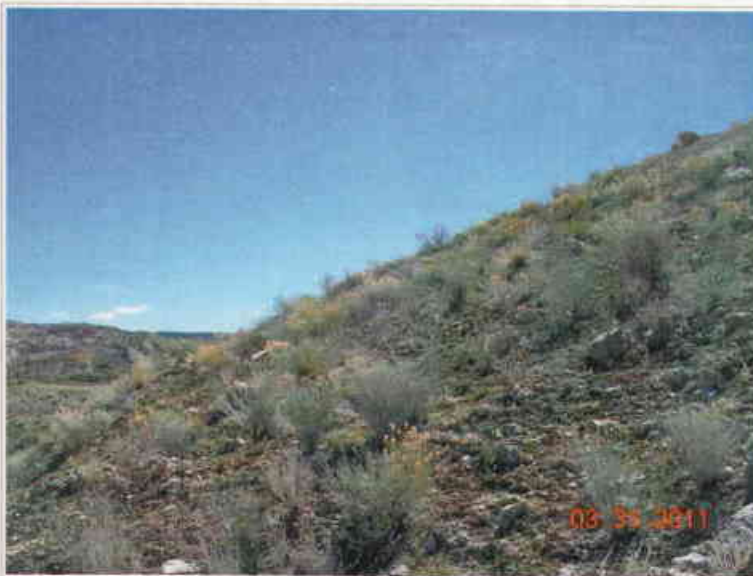
A generally north-facing, steep, revegetated slope in B5.

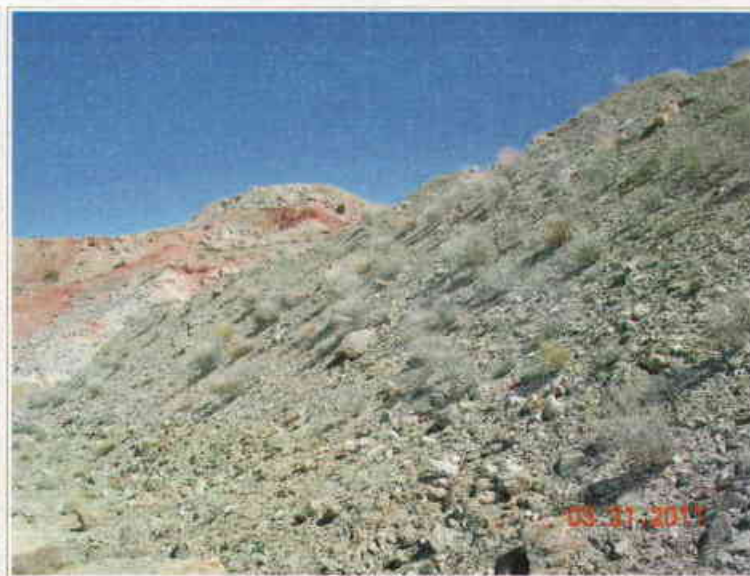
Example of successful revegetation on a steep reclamation slope in the Bowl area.

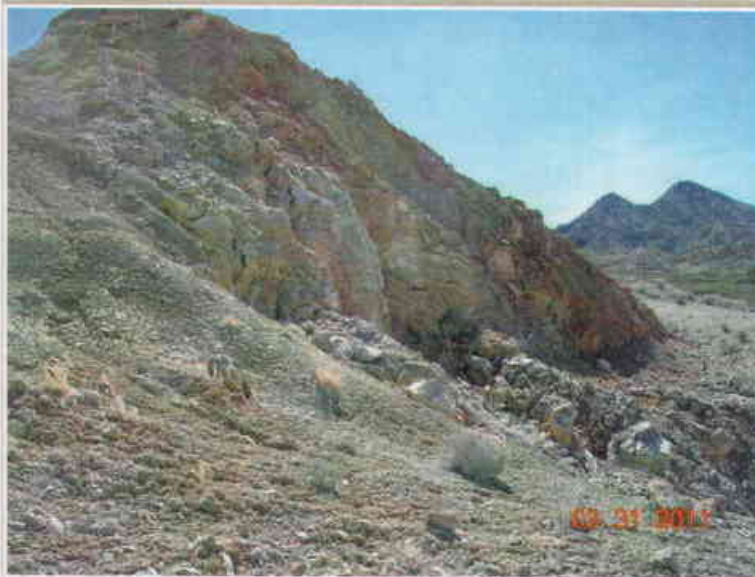
Baseline data reported in the 1987 NOI indicate a vegetative cover of 5% on steeper hillsides and south slopes, and 10% cover in lower areas and north slopes. All of the revegetated areas inspected by Paul Baker on March 31<sup>st</sup> have cover equal to or greater than 70% of the baseline, and with the exception of area B5, all are recommended for full bond release. Documentation photos were taken. A mining-created, fractured outcrop in B5 with an overhang needed to be pulled down to a stable condition before being fully released.

Highwall in B5 that needs to be reduced. Note the cracks and slight overhang.

The areas requested for release in F1, Center 4A, 6A&6B, and the Bowl/Hogback/Claw/3Sisters areas (15.8 acres total) of revegetation are recommended for full release. The outcrop in area B5 needs to be taken down to a stable condition before reclamation of this revegetation will be released for this area (3.7 acres).

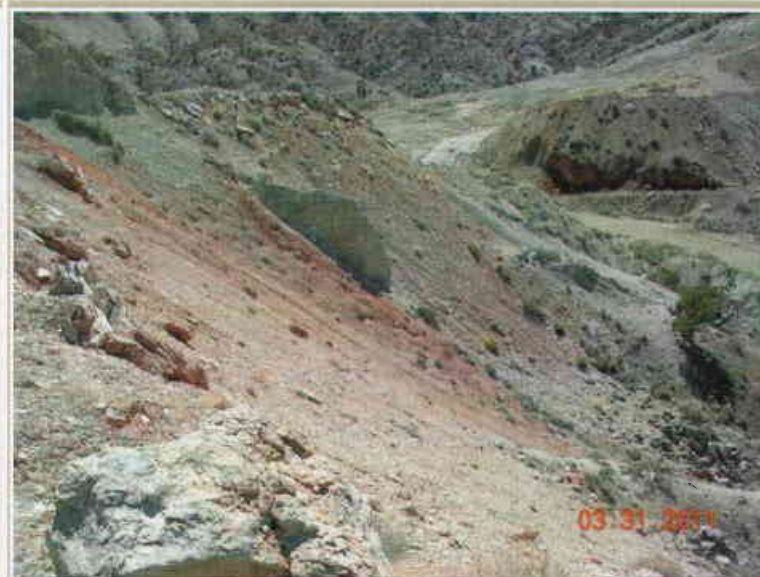
Steep pre-law slope with vegetative cover comparable to some natural steep and south-facing slopes.

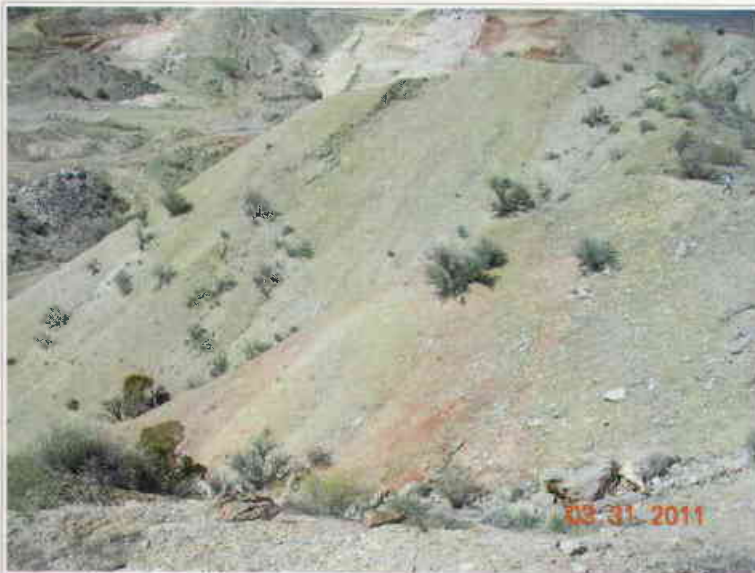
Natural slope with very little vegetation. These slopes have been (and appear to have been) eroding over a much longer period of time than mining slopes.

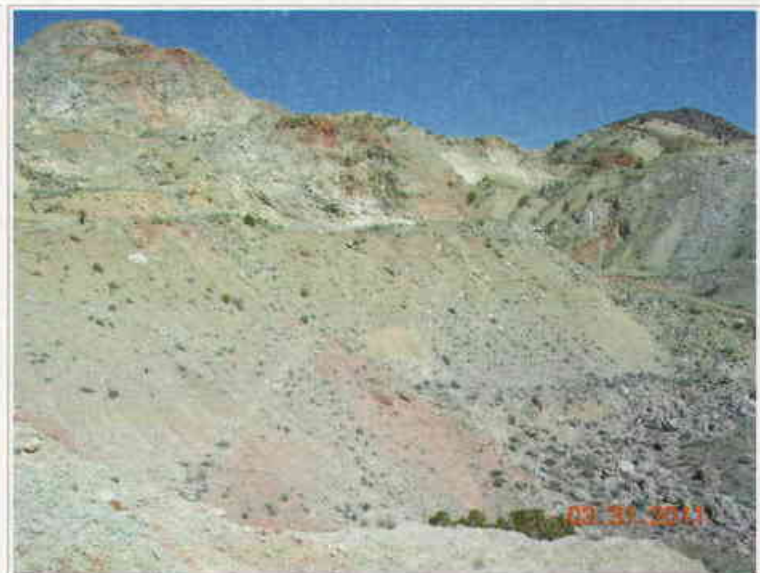
Pre-law steep slope near J45 with significant vegetation (photo from J45). Pre-law highwalls shown at the top of the photo. Boulders collect below.

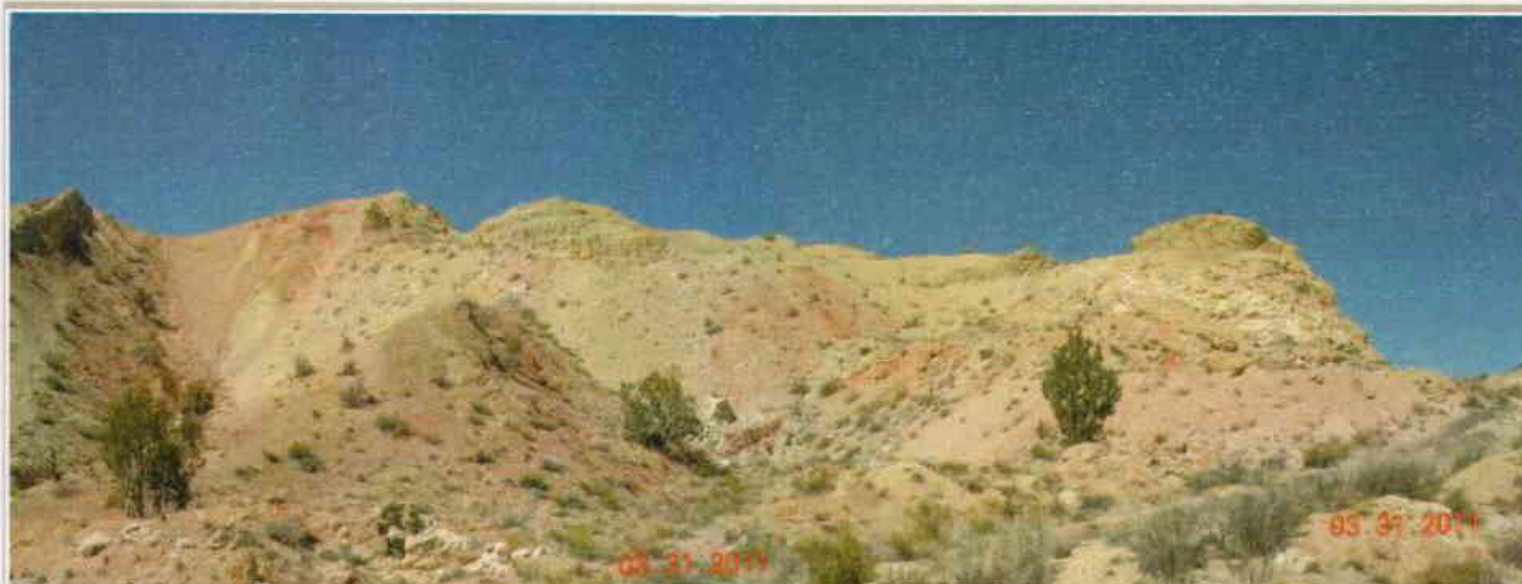
Natural (darker) and pre-law mining (lighter) slopes with some established vegetation east of the Jumbo Quarry. No indications of waste rock slope instability were observed. Stitched photo.

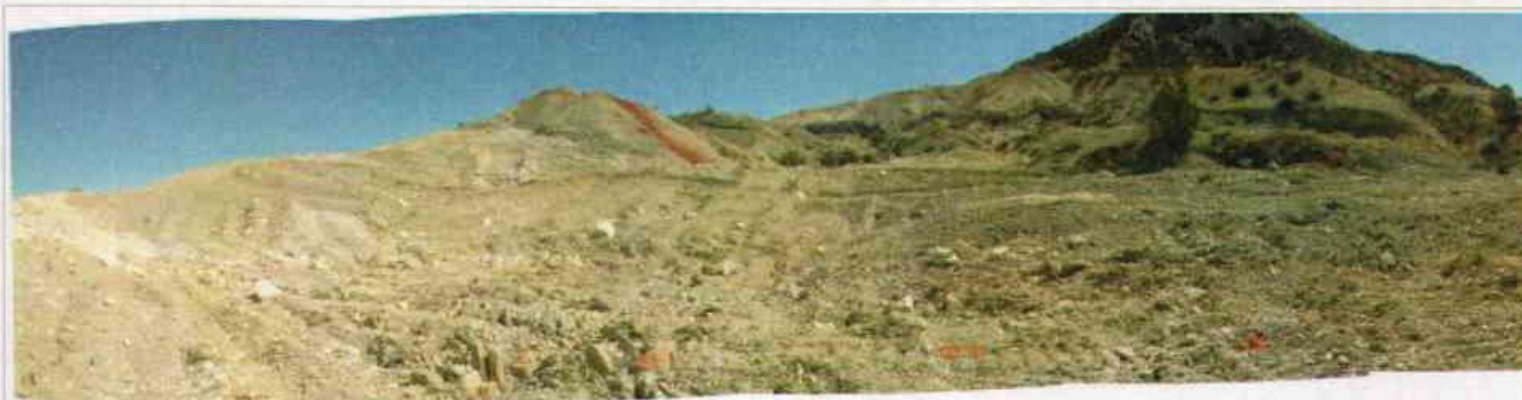
Current Wishbone regrading to approximate 2h:1v slopes. These slopes were approved and are reseeded. Other Wishbone slopes were not inspected at that time. Stitched photo.

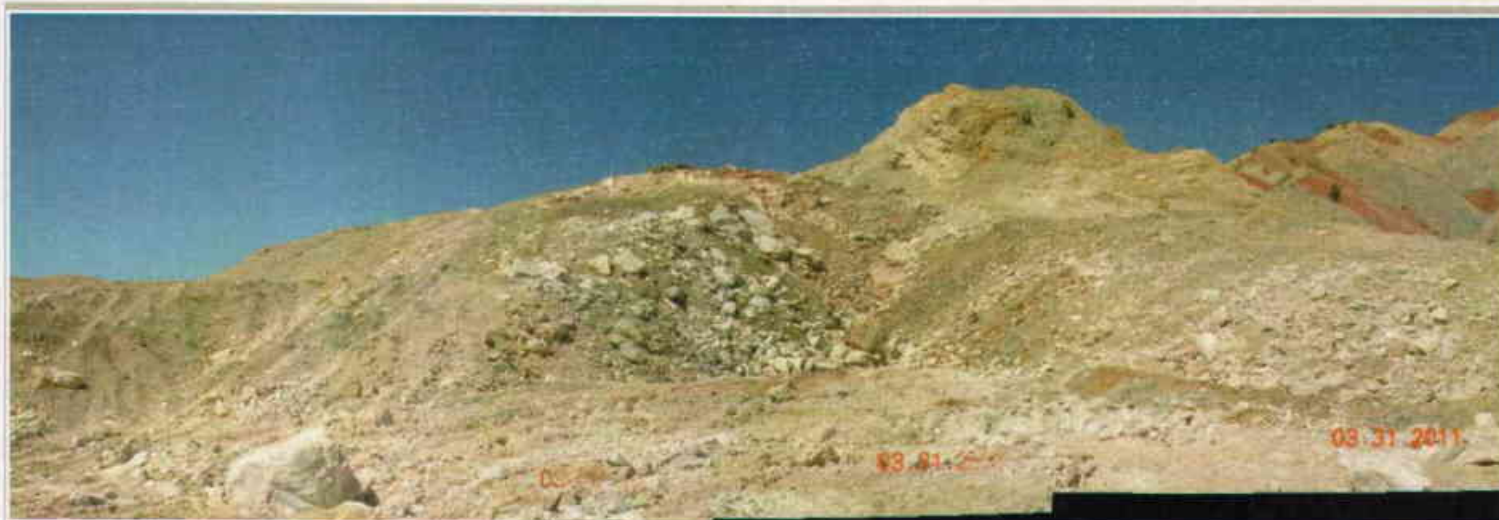
J45 recontoured slopes. Stitched photo.

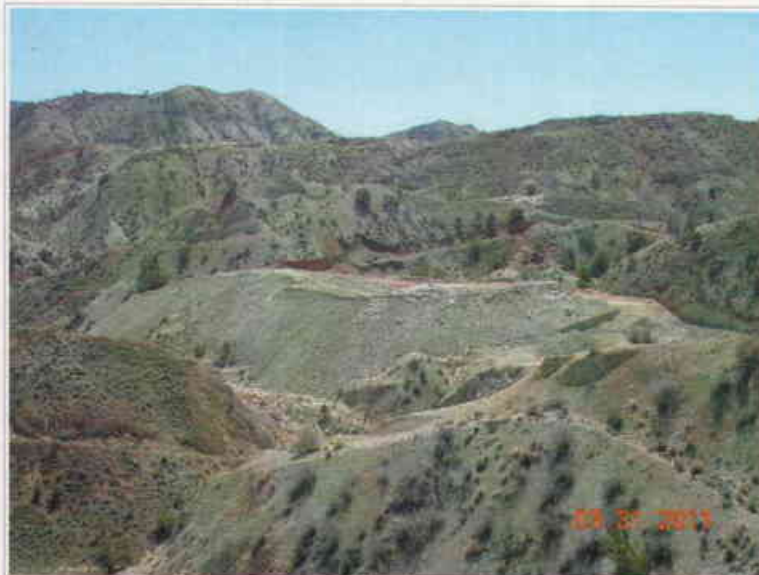
J52 recontoured slopes.

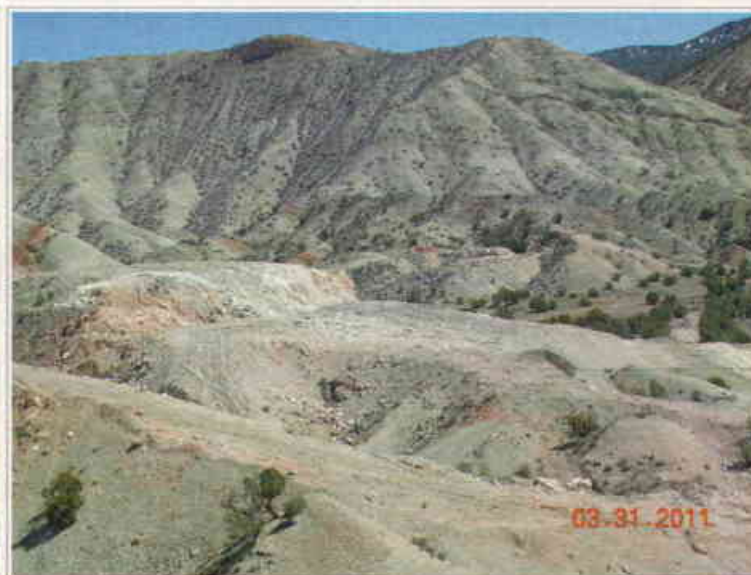
J57 recontoured slopes.
